Performance of HUD-Affiliated Properties During the January 17, 1994 Northridge Earthquake

August 1994
Building and Fire Research Laboratory
National Institute of Standards and Technology
Gaithersburg, MD 20899

Prepared for:
U.S. Department of
Housing and Urban
Development

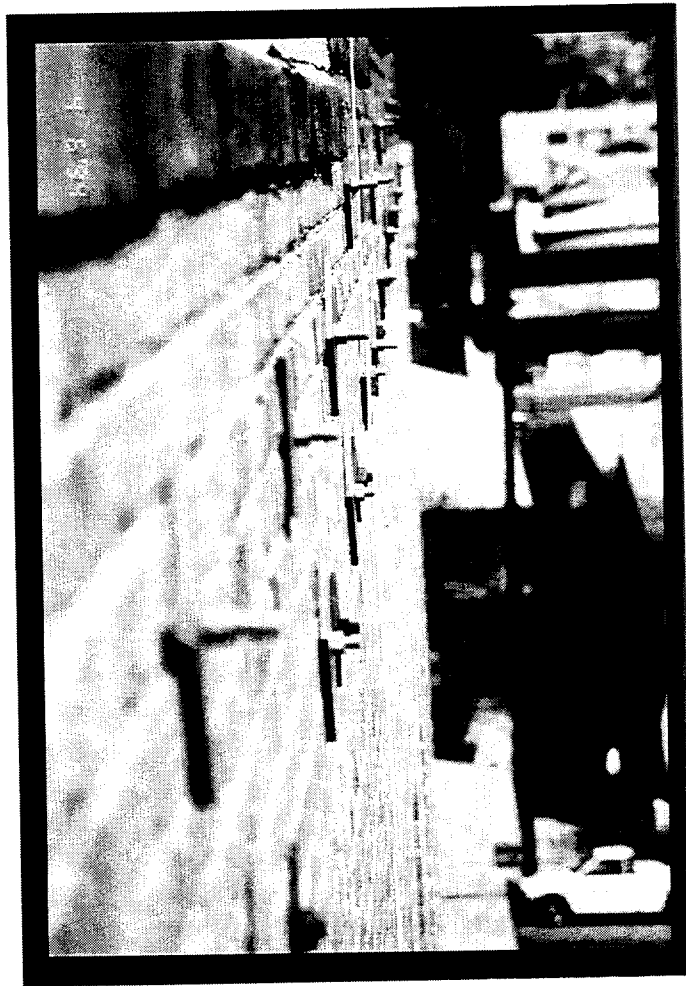
Figure 8 Pre-earthquake seismic rehabilitation of unreinforced masonry buildings typically included face plates and through-bolts anchoring the walls to the floor and roof joists.

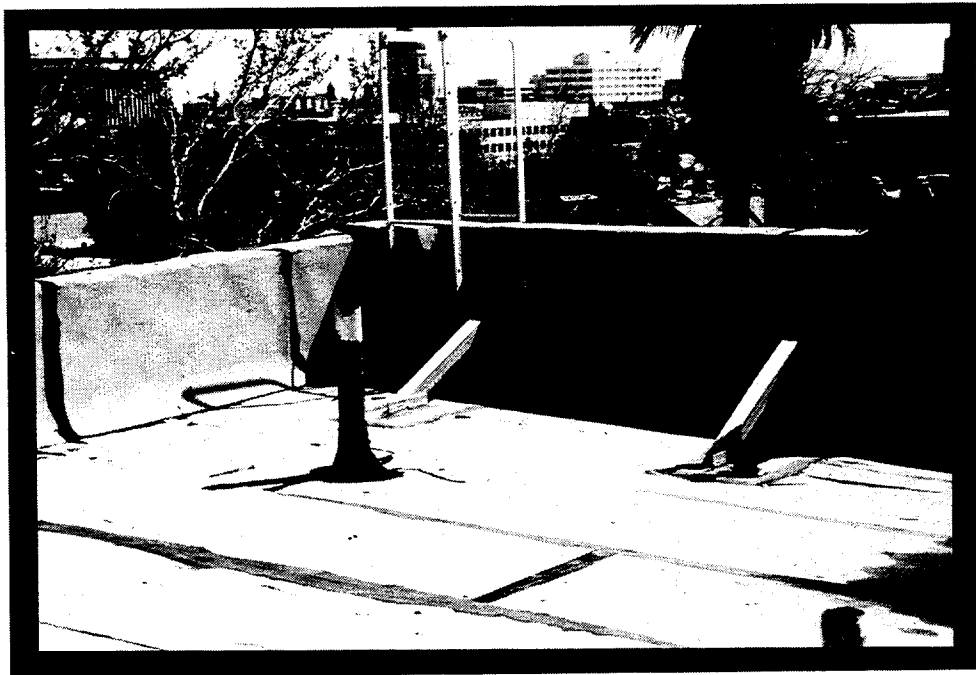
Figure 9 Unreinforced masonry buildings that had been rehabilitated prior to the earthquake typically had had their parapets braced.

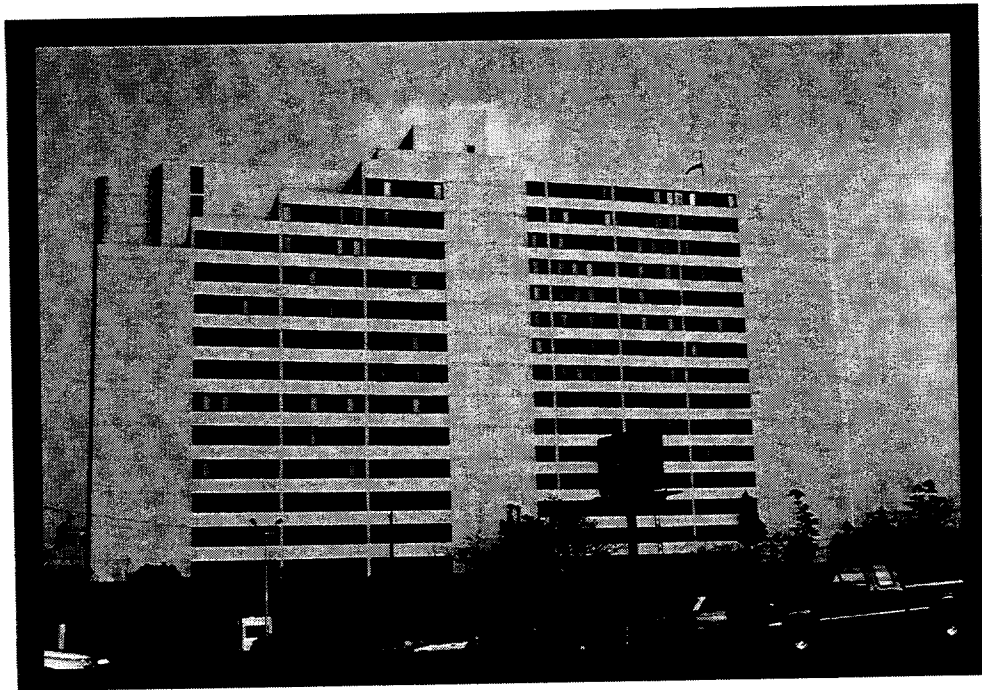
Figure 10 Cathay Manor, a 16-story building about 33 km from the epicenter, was determined to be a concrete shear wall building.

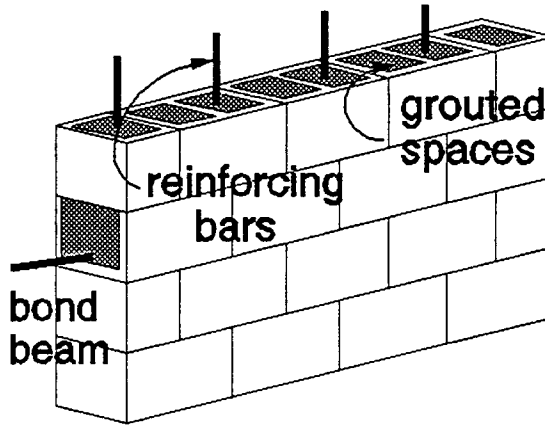
Five sites had reinforced masonry buildings. Three of the sites were from the stock of public housing; the sites had been selected for inspection by local public housing officials. The three public housing sites (Aliso Apartments, Ramona Gardens, and William Meade Apartments), each about 35 km from the epicenter, had 147 buildings among them. Although these sites were apparently on the local public housing administration's list of earthquake-damaged facilities, the BFRL inspection teams found no evidence of earthquake damage at the three sites. Minor cracking was observed in the masonry in some locations but it appeared to be unrelated to the earthquake.

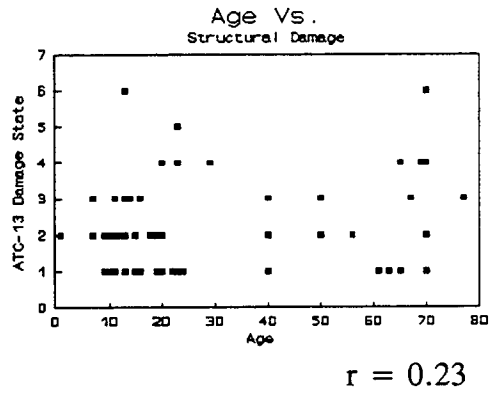
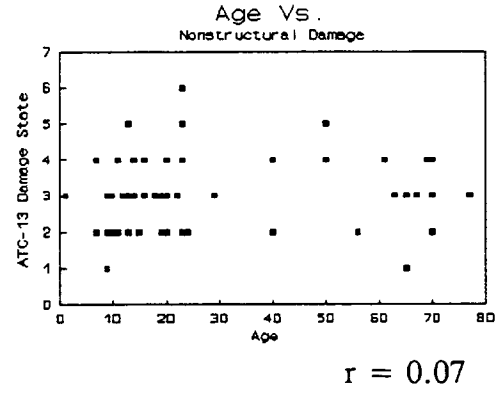
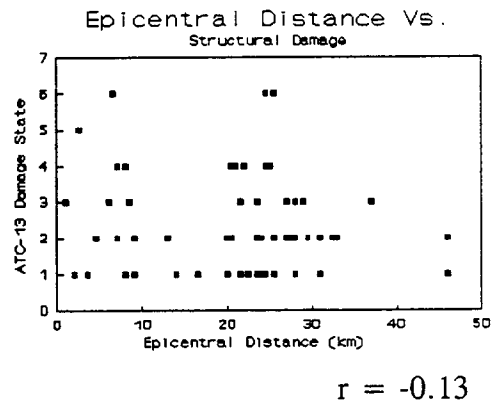
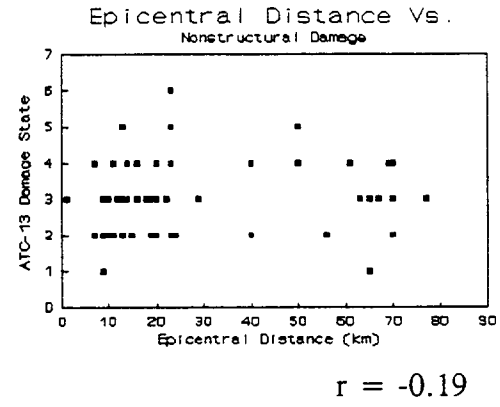
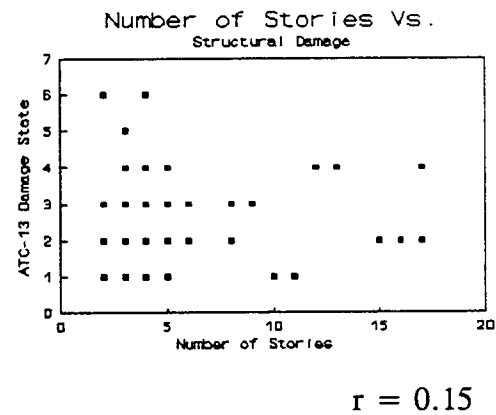
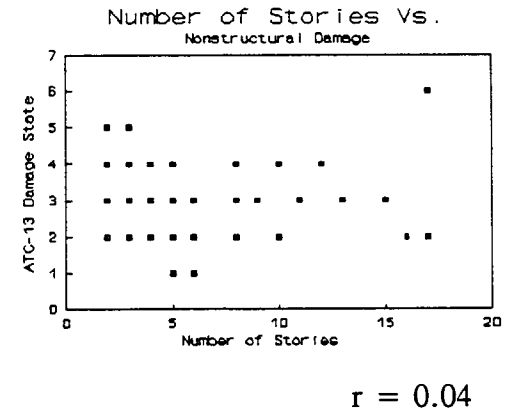
Figure 29
Scatter Plots and Coefficients of Correlation
Age, Epicentral Distance and Number of Stories
Compared to Structural and Nonstructural Damage States

Scatter plots were produced, evaluating each site as one data point. The scatter plots showed a wide distribution of damage states for each of the variables considered (fig. 29). Note that, as can be seen from the data in Table C, each of the dots shown in figure 29 may represent more than one data point. Regression analysis confirmed that no statistically valid trends existed in the data for age, number of stories, or epicentral distance (considered individually and ignoring the influence of the other parameters) when measured against structural and nonstructural damage states. The correlation coefficient, r , was greatest for the correlation between age and structural damage, but, with a value of only 0.23, the correlation cannot be considered significant. The correlation coefficient r always has a value between -1 and 1; these values imply perfect correlation. A value of zero indicates no correlation whatsoever.

It is possible that strong trends do exist in more narrowly defined groupings of data which consider the combined effects of multiple variables, for example, age-to-damage state correlations for each different structural system, rather than for all systems considered together. However, the relatively limited number of data points available from this study does not justify more finely partitioned analyses. Given a larger set of data points, trends may well become apparent.

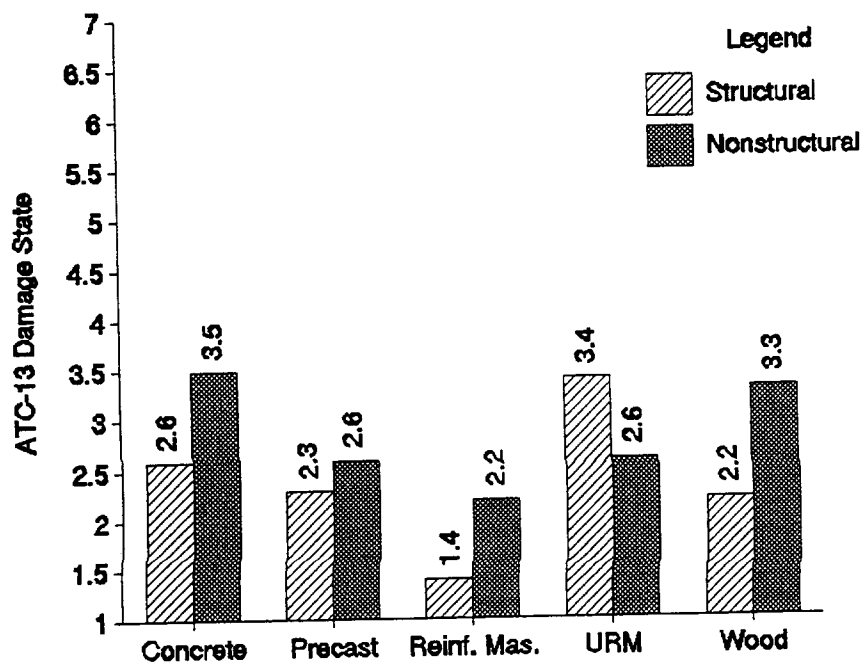
Figure 30 Bar graph showing weighted averages of ATC-13 structural and nonstructural damage states by structural system.

The highest average damage state was 3.5, for non-structural damage in concrete buildings, which is between "light" (1%-10%) and "moderate" (10%-30%) damage. The lowest average value, 1.4, for structural damage in reinforced masonry buildings, is between damage rated as "none" (0%) and "slight" (0%-1%).
